**RE: Assessment of Potential Mitigation Opportunities within Caltrans' Right-of-Way  
near Montara Creek, San Mateo County**

## **Caltrans Montara Creek Potential Mitigation Opportunity Assessment Appendix of Photographs**

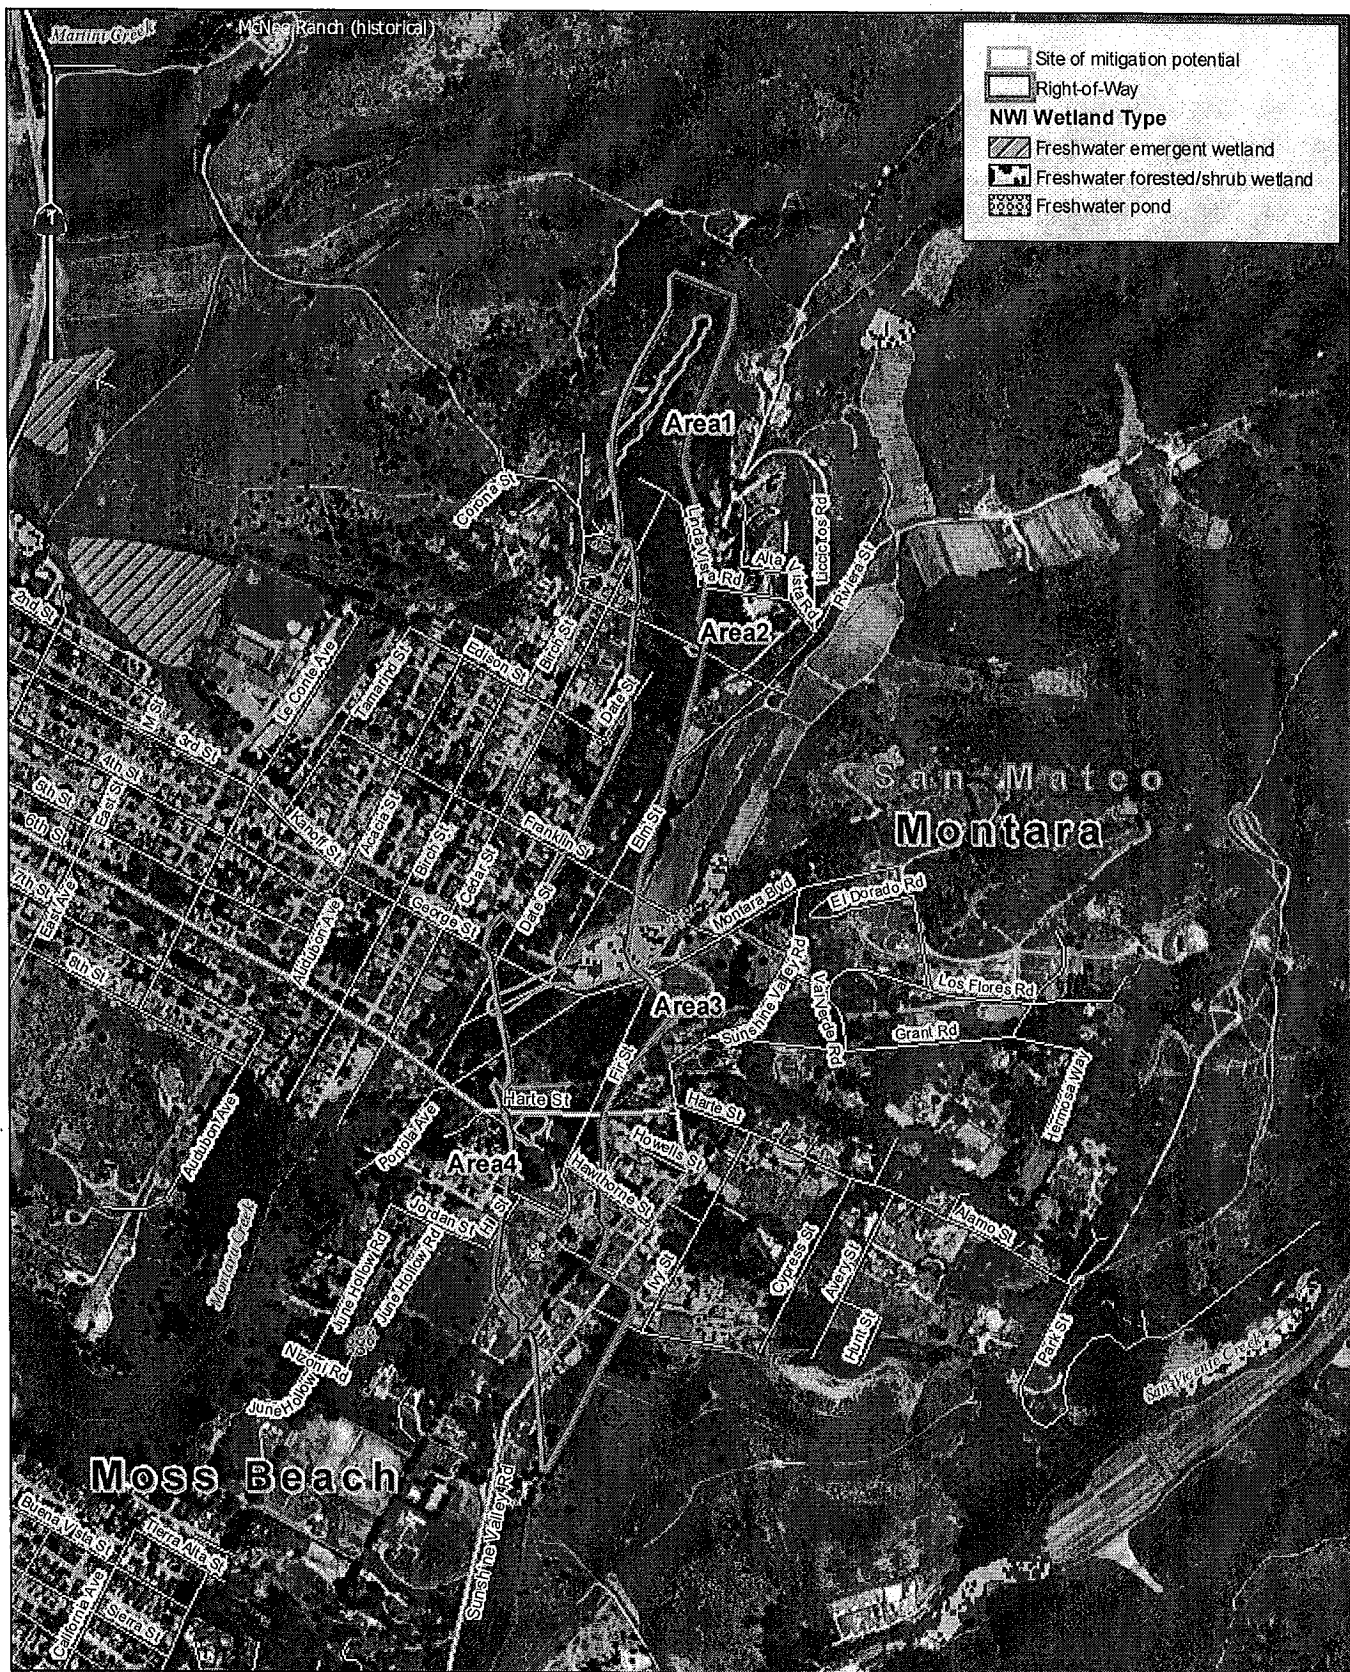
Figure 1. Montara Creek potential resources

The Caltrans ROW property is located within the eastern residential district of Montara (Figure 1). The ROW is approximately 64.6 acres. The ROW property is a linear swath of land that is divided by several paved residential streets. The southern boundary is located southeast of Sunshine Valley Road. The northern boundary extends past Cedar Street near the southern boundary of Daffodil Canyon, which is a potential mitigation site previously identified by Caltrans. The western boundary is defined by a line roughly parallel with Date Street. The eastern boundary is bordered by agricultural fields and Alta Vista Road.

Four areas were identified to have potential for mitigation opportunities (Figure 1):

- Area 1, a potential CCC wetland area and California red-legged frog habitat located north of Cedar Street
- Area 2, a potential CCC wetland area located near Drake Street
- Area 3, a potential CCC wetlands area and potential California red-legged frog habitat located along Montara Creek
- Area 4, a potential CCC wetland area located south of Harte Street

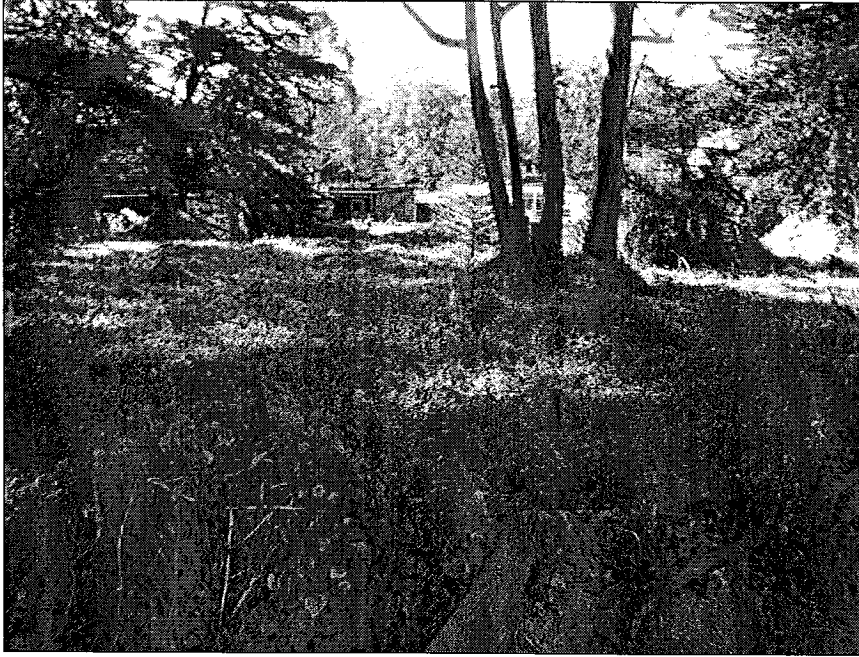
The southern portion (from Sunshine Valley Road to Hawthorne Street) of the ROW property consisted primarily of residential development, horse stables and corrals (see *Appendix of Photographs*: Photo 1, 2, 3). The area from Irving and Hawthorne Streets to the southeast of Sunshine Valley Road has been leased from the State and is consequently fenced property. At the time of our site assessment we did not have property owner approval to access the ROW and therefore we did not directly access this location. We were able to view most of the ROW to which we did not have access from paved roads (end of Hill and Jordan Streets).

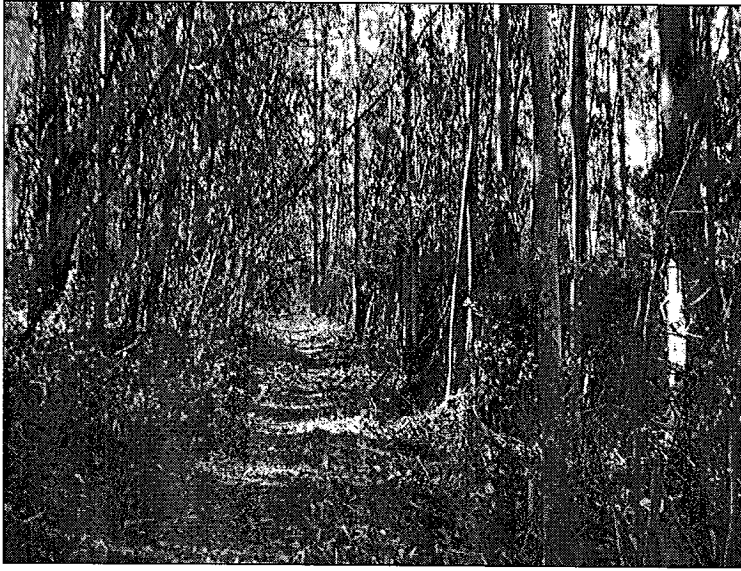
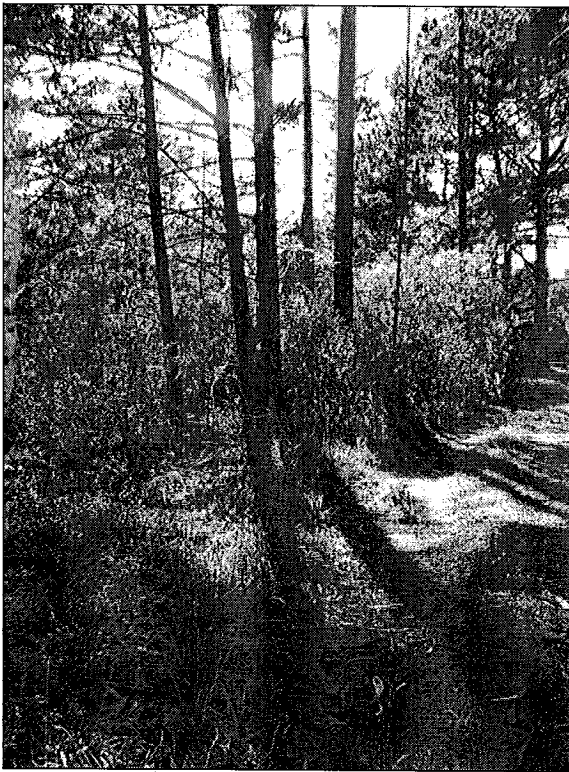
The area north of Hawthorne Street to Linda Vista Road is the largest portion of the ROW. The area was composed primarily of ruderal forest dominated by non-native species consisting of Monterey pine, Eucalyptus, poison oak (*Toxicodendron diversilobum*), California blackberry (*Rubus ursinus*), Himalayan blackberry (*Rubus discolor*), western sword fern (*Polystichum munitum*), periwinkle (*Vinca minor*), and pampas grass (*Cortaderia selloana*). Horse paths transect a portion of this section, including several two-track paths west of Fir Street (Photos 5, 6, 7).

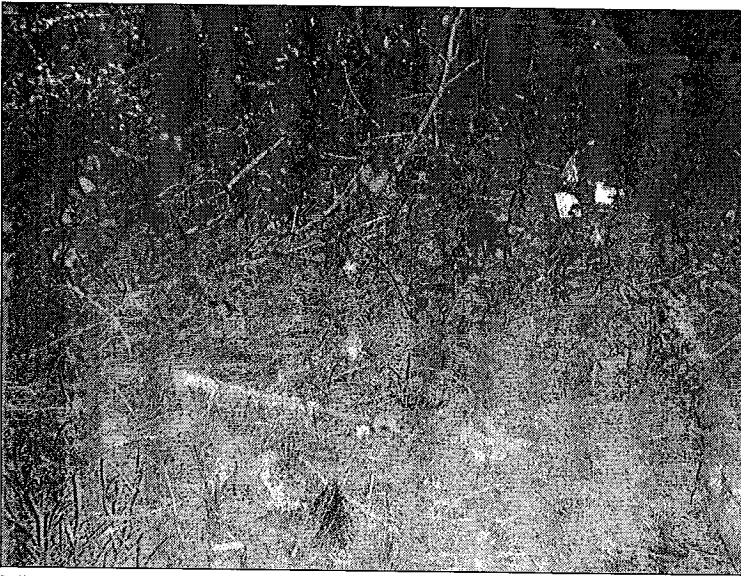
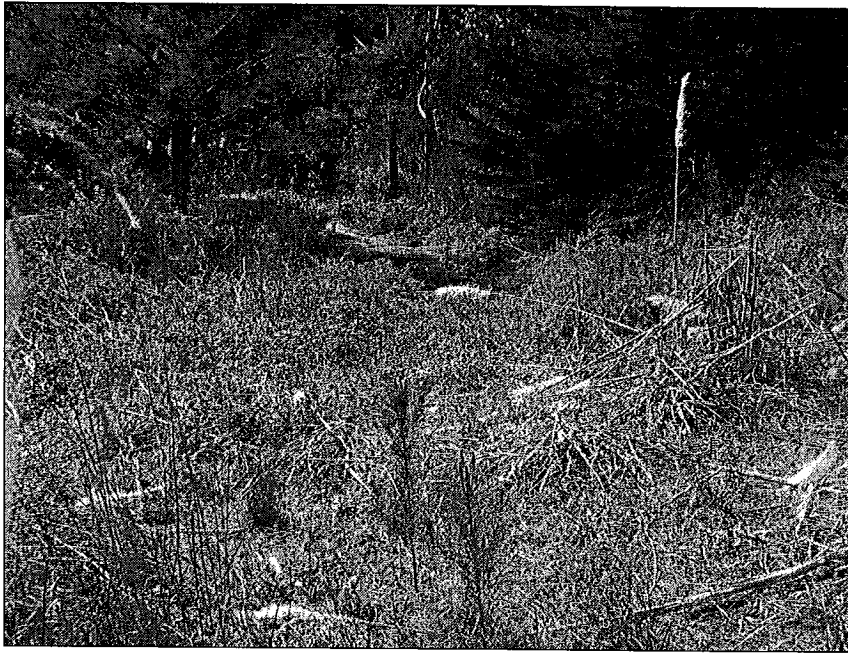
The northernmost section of the ROW property (north of Linda Vista Road) was composed primarily of Monterey cypress (*Cupressus macrocarpa*), Monterey pine, wax myrtle (*Myrica californica*) poison oak, periwinkle, and pampas grass (Photos 8, 9). A dirt road transected the area and is expected to be utilized as an access road for the potential Daffodil Canyon Mitigation site, which is currently located on property held by Caltrans. At the very northern terminus for the survey area, as terrain leads up hill toward Daffodil Canyon, vegetation is consistently dominated by Monterey cypress and pines. However, just north of the ROW the vegetation becomes more typical of coastal scrub.

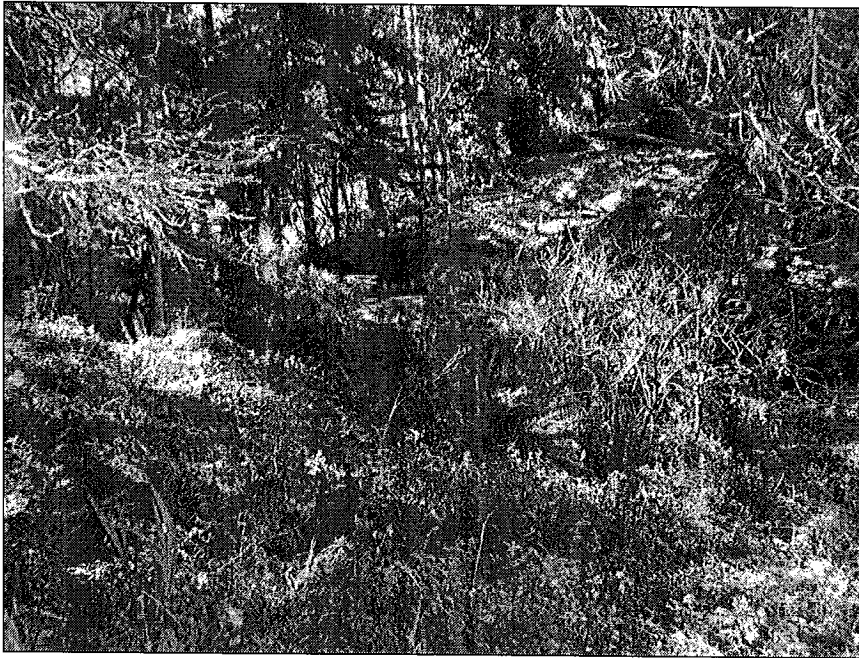
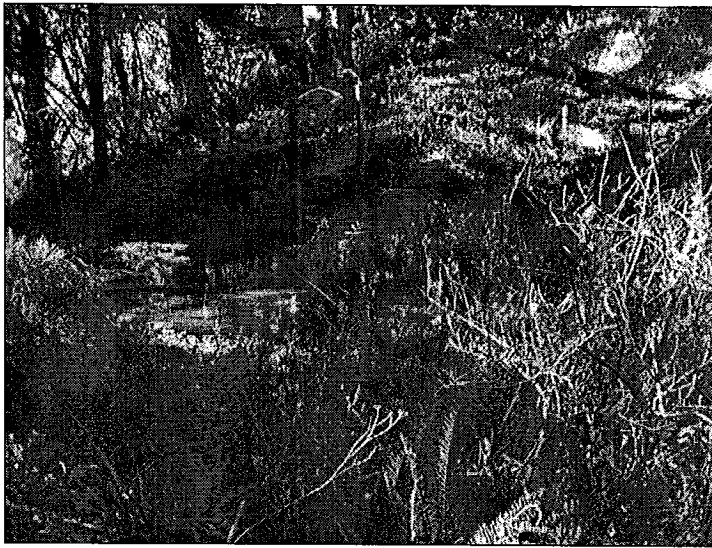
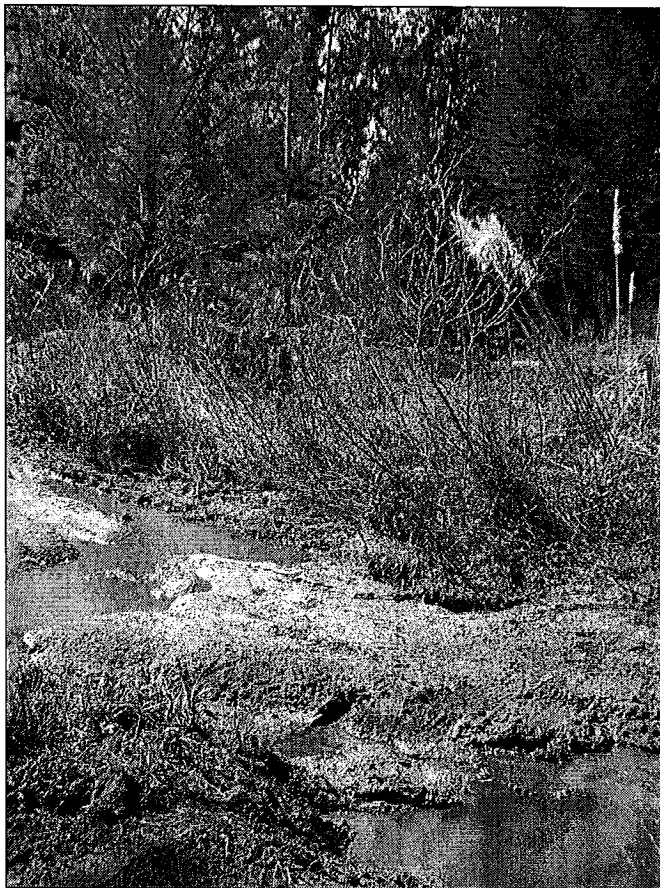
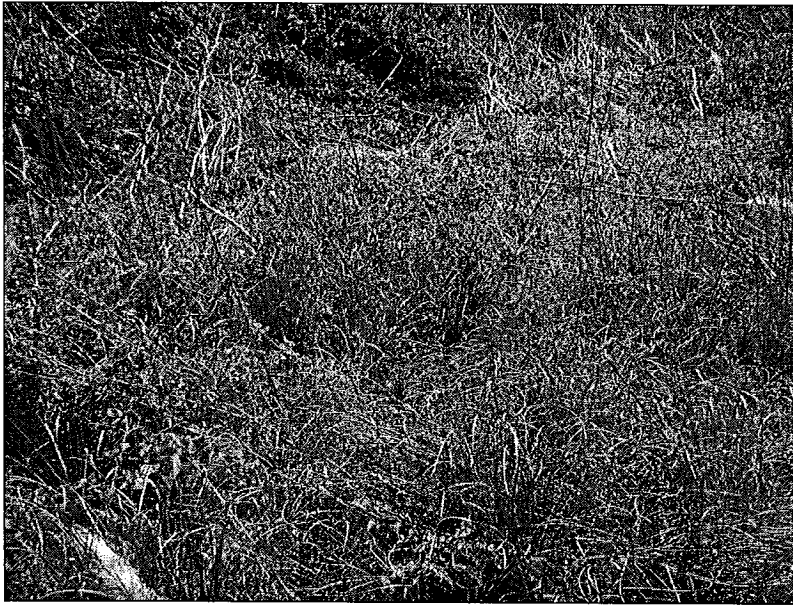
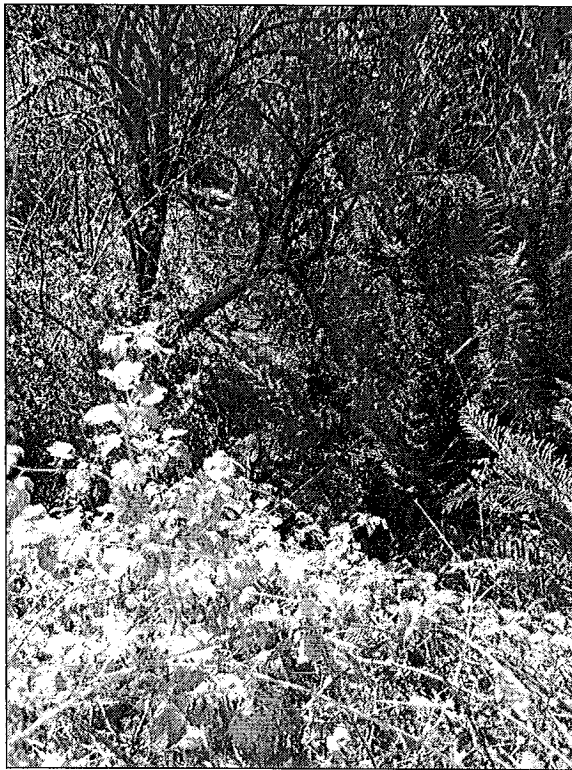
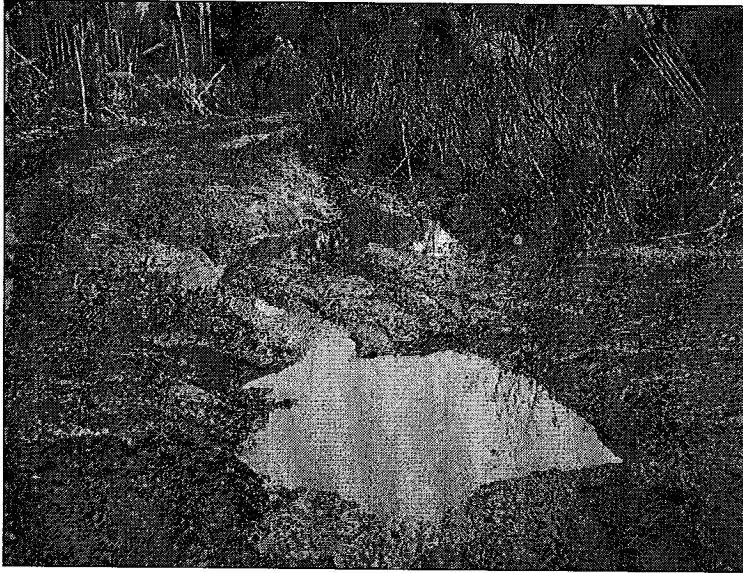
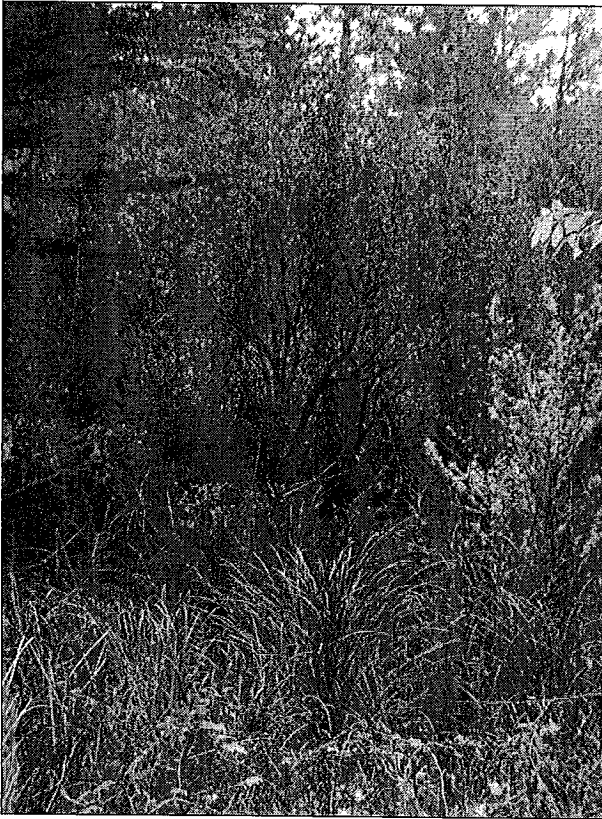
Area 1 was located in the northern section of the ROW property and covered approximately 63,400 feet<sup>2</sup> (1.4 acres, 5890 meters<sup>2</sup>; 0.6 hectares). A pond was located at the most southwestern section of this area and it appeared that a portion of the pond may be located within the ROW (Photo 10, 11). An unnamed intermediate creek/drainage fed into the pond (Photos 12, 13, 14, 15, 16). The unnamed creek or drainage is generally two feet wide and would likely be considered as a jurisdictional Waters of the U.S. Vegetation throughout this location consisted primarily of California blackberry, Cape ivy, stinging nettle (*Urtica dioica*), box-elder (*Acer negundo*), wax myrtle, rush (*Juncus* spp.), yellow monkey flower (*Mimulus guttatus*), vetch (*Vicia sativa*), Monterey cypress, pampas grass and eucalyptus.

This area had potential mitigation opportunities for CCC wetlands and for the federally threatened California red-legged frog (CRLF). Ponds could be installed and habitat for California red-legged frog could be developed. It is likely that if ponds were constructed at Area 1, they would be colonized naturally by California red-legged frogs. The nearest known occurrence of the species is at the mitigation site for the Devil's Slide Tunnel Project, located downstream from Area 1, which is within the migration distance of that species.

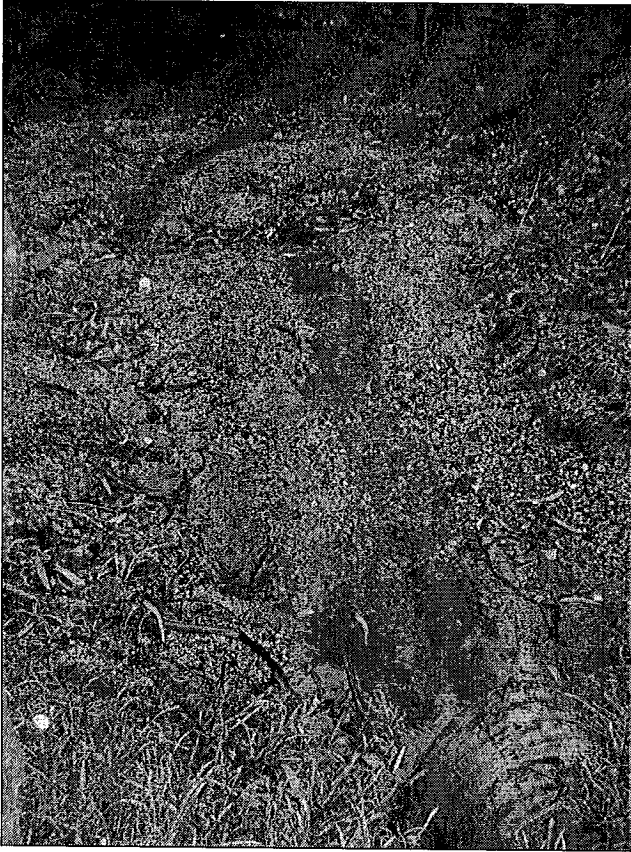
**Photo 17 – Area 2**

Area 2 was a small potential CCC wetland located just south of Drake Street. A road side drainage ditch fed into this location via a one foot wide corrugated steel culvert (Photo 17). Dominant vegetation consisted of California blackberry, eucalyptus and Monterey cypress. Understory vegetation included curly dock (*Rumex crispus*), beet (*Beta vulgaris*), salmonberry (*Rubus spectabilis*), hedge nettle (*Stachys rigida*), ripgut brome (*Bromus diandrus*), poison hemlock (*Conium maculatum*) and umbrella sedge (*Cyperus eragrostis*) (Photos 18, 19).

The Area 2 location has potential mitigation opportunities for developing a CCC wetland. Limitations of this location include the area's close proximity to Drake Street, the small size of the area (approximately 3,470 feet<sup>2</sup> (0.08 acres) and the artificial roadside drainage as a water source. In addition, this location also appeared to have a well-used horse trail running east to west through the most southern section.

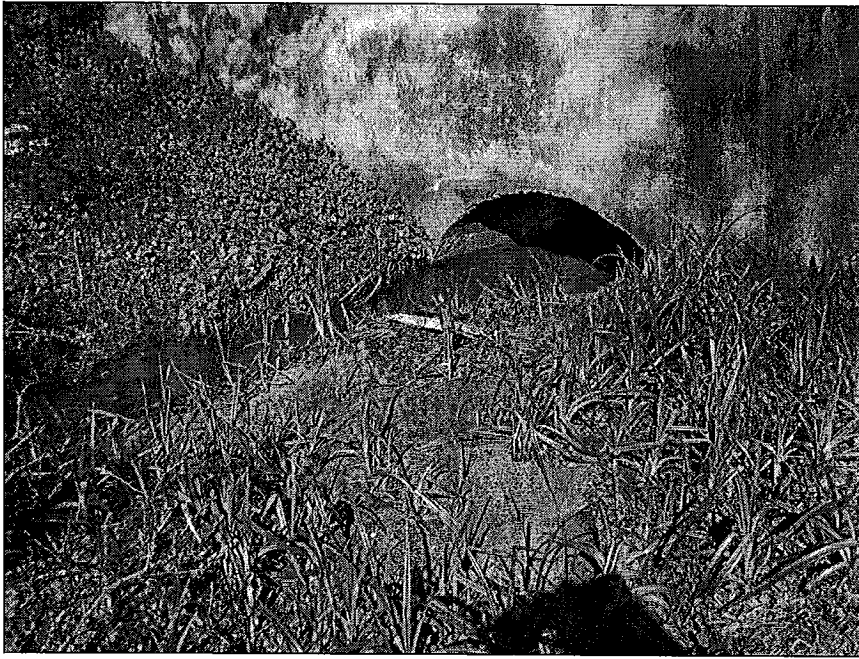
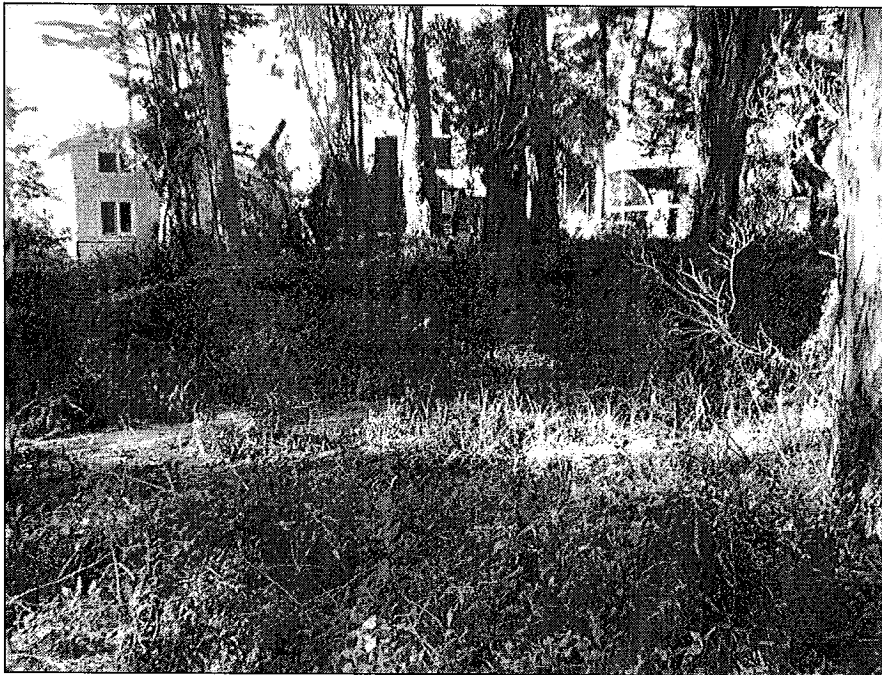
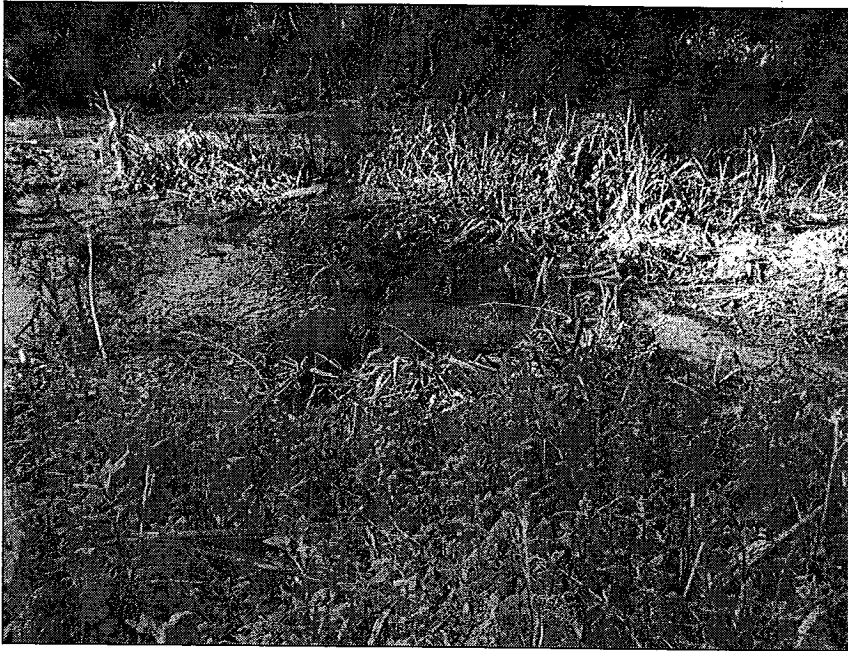
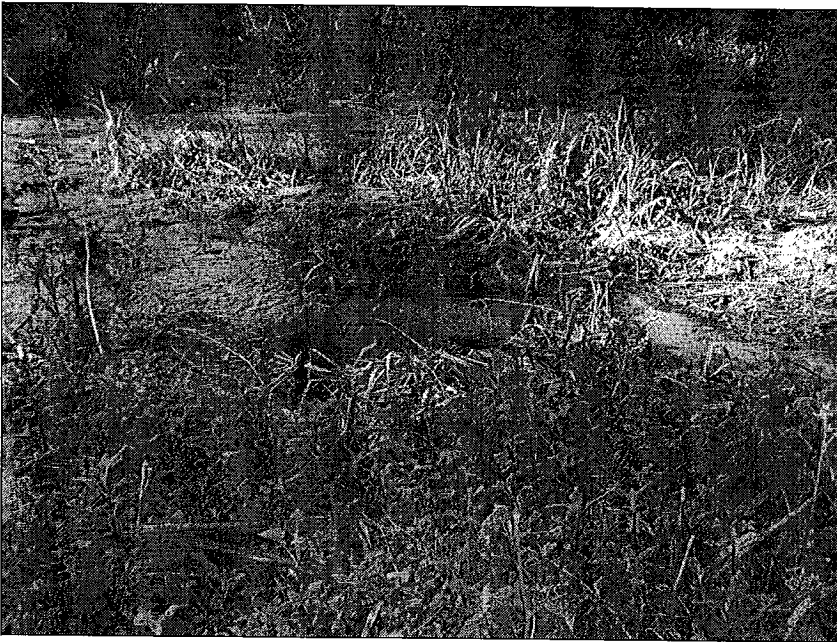
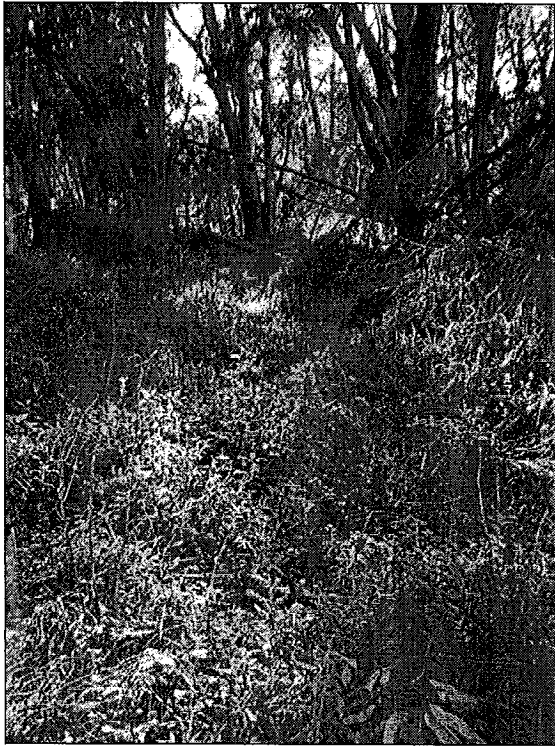
Area 3 was approximately 3.5 acres of riparian habitat along Montara Creek (Photo 20-26). The dominant vegetation throughout this location consisted primarily of willows (*Salix* spp.), curly dock, ripgut brome, hedge nettle, stinging nettle, Himalayan blackberry, western sword fern (*Polystichum munitum*), periwinkle and pampas grass. Stands of eucalyptus were present outside the riparian zone.

The 3 to 5 foot swath of Montara Creek is likely to be a jurisdictional Waters of the U. S. We also found that the location supported potential mitigation opportunity for enhancement to a potential CCC wetland and potential habitat for CRLF. North of the George Street Bridge the topographic gradient is too steep for ideal CRLF habitat; however, southwest of the George Street Bridge, Montara Creek widens and provides greater potential for CRLF habitat creation.

Limitations of this area are the ruderal nature of the forest, dominated by eucalyptus, the proximity of Montara Creek to residential homes, and the fragmentation of this area by paved roads (Elm and George Streets). Along the southwest portion of Montara Creek, adjacent residential yards appear to allow access to the creek from Date Street. Furthermore, there are numerous paths (foot paths and two-track vehicle paths) throughout the forest adjacent to Montara Creek.

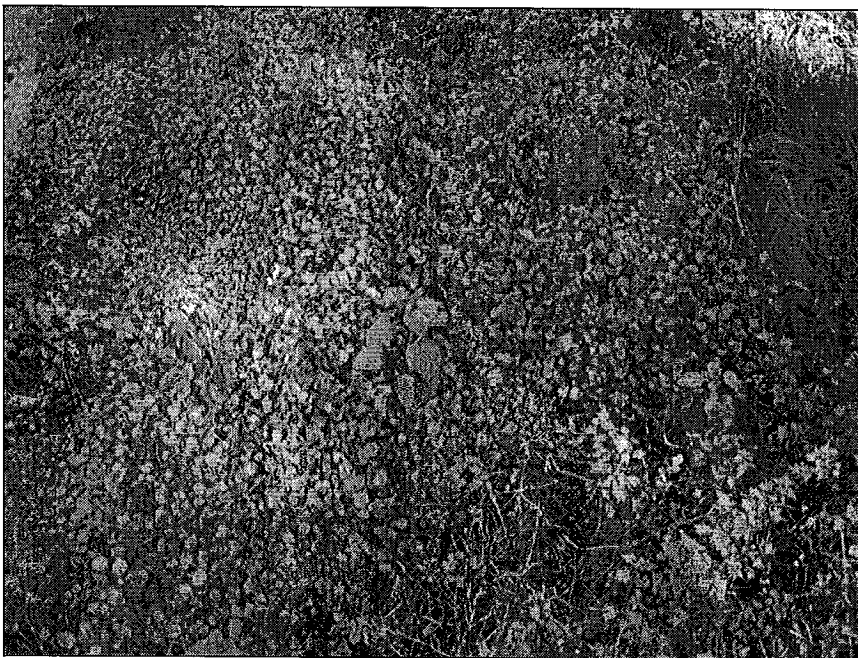
Area 4 was located just south of Harte Street and was approximately 0.4 acres (Photos 27, 28, 29). Dominant vegetation throughout this location consisted of watercress (*Nasturtium officinale*),

stinging nettle, rush, horsetail (*Equisetum arvense*), poison hemlock, cape ivy, calla lily (*Zantedeschia* spp.), California blackberry and Himalayan blackberry.

This location was considered to be potential CCC wetland. It is fed by two roadside drainage ditches. The top outlet, located at Hawthorne Street, fed this location from approximately 45 degree slope above this area and the second outlet drains from Harte Street into the northern section of the area. The location offers opportunities to enhance existing potential CCC wetlands. The limitations of this area include the small size of the area, the proximity and fragmenting effects of paved residential streets, and the water quality limitations of being fed by artificial road side drainages.
